TEST REPORT

Report No : THSH18122416508-EN Date: Jan. 04, 2019

Sample Description : Rotary encoder

Test Requested : IP68

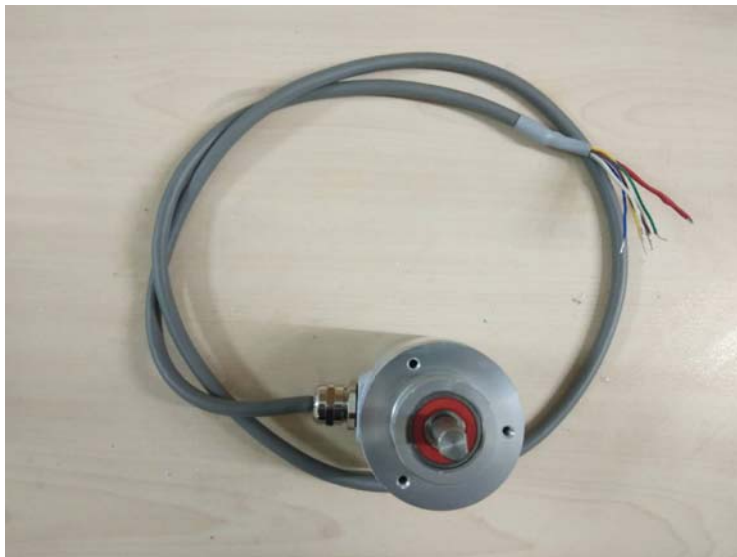
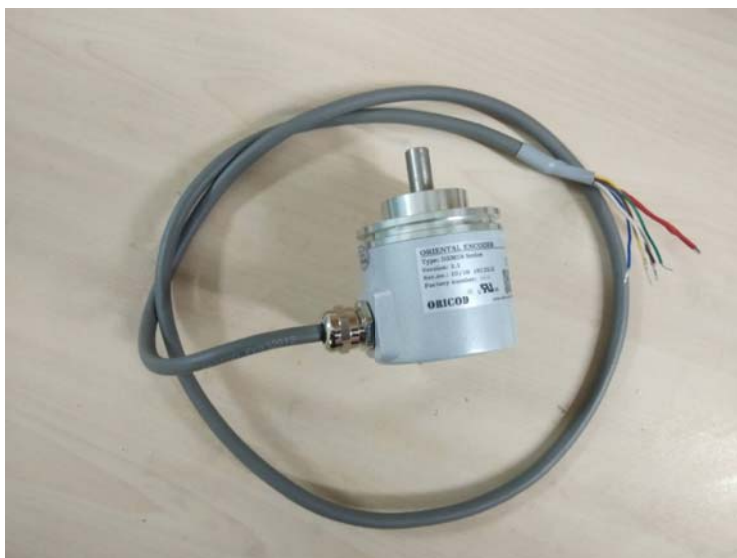
Sample Photo

Model No. : DXM58 Series , DXM38 Series

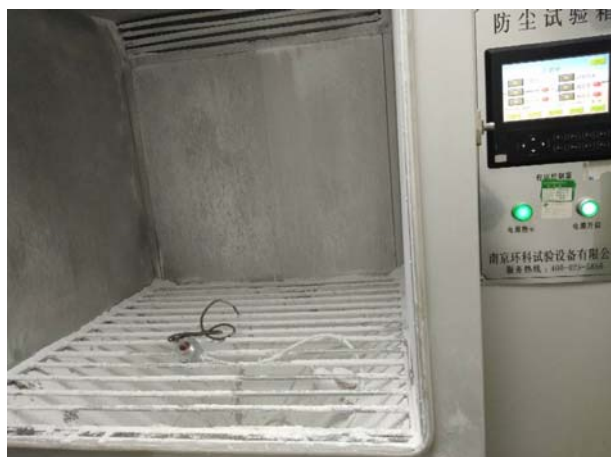
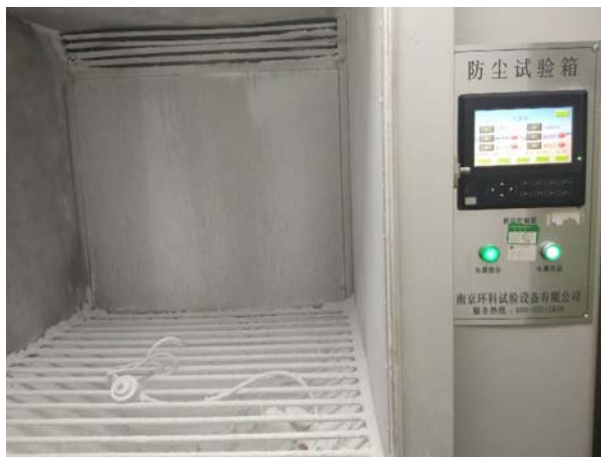
Sample Photo(s) during the test:

Test Setup: Dust-proof chamber, Model No. SC-010

- 1) Maximum depression : 2kPa.
- 2) Test period: 8 hours
- 3) Extraction rate: 40 volumes per hour

Sample Name	Test Results
Rotary encoder	No dust observed inside the test sample

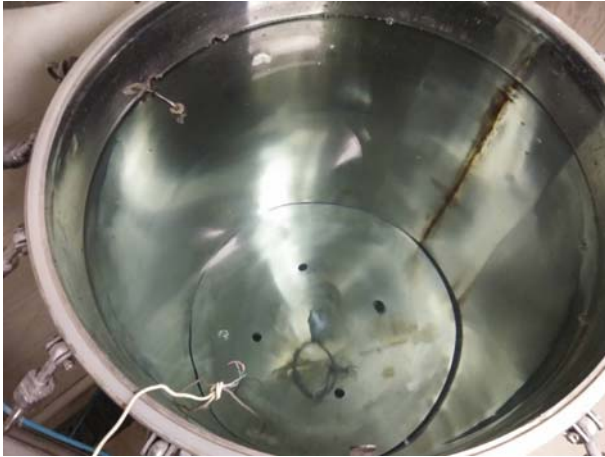
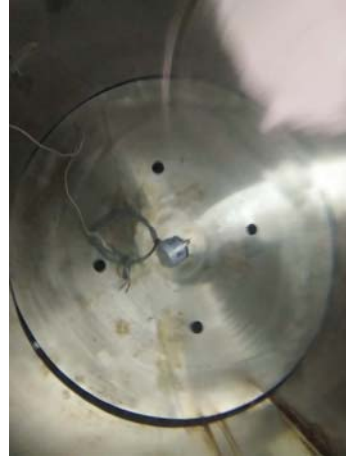
Sample Photo(s) during the test:

Test setup: Water proof test apparatus, No. IPX1-8

Test Conditions: 1) Depth of water: 1m
2) Test period: 1h

Sample Name	Test Results
Rotary encoder	No water entered the cavity of sample after this test
