## TEST REPORT

Report No : THSH18122416507-EN Date: Jan. 13, 2019

Sample Description : Rotary Encoder

Model No. : DXM58 Series , DXM38 Series

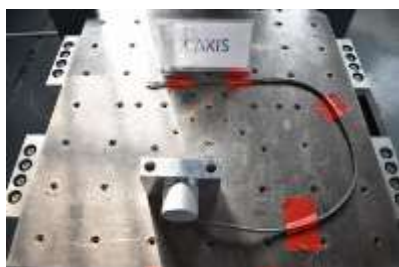
X Axis

#### 1.4 Test Setup

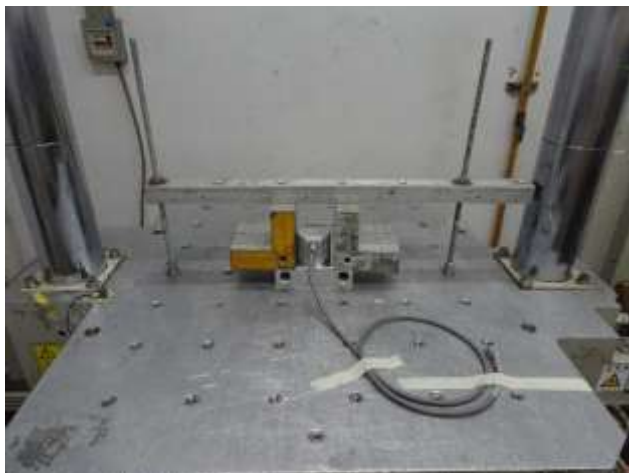
bottom

#### 2.4 Test Setup

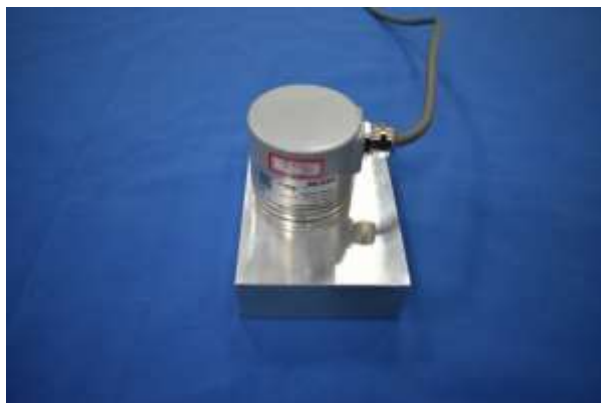
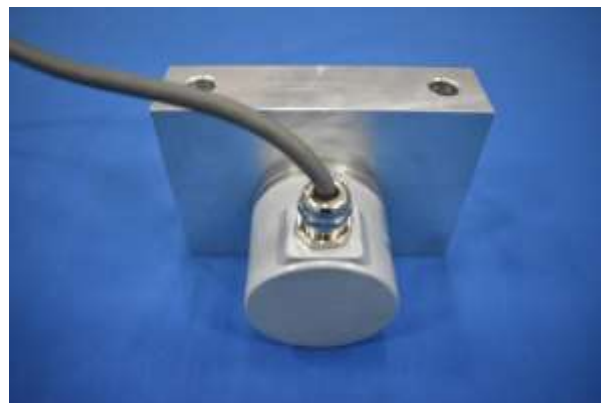
- Sample photo(s) after test

| Sample Number | Test Results |
|---|---|
| 01 | After testing, the appearance of the sample is normal. |
