GZMR240701850001

Sample Name : stainless steel rings

Test Item: Neutral Salt Spray (NSS) Test Sample Description: Metal product Test Method: ISO 9227:2022

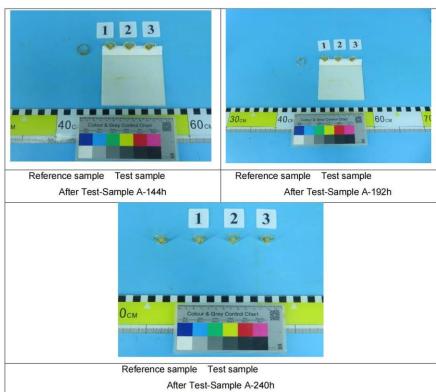
- 1. After 96h exposure, the sample was placed at room temperature for 168h. And then the exposure test was performed for another 144h. The total exposure period is 240h. The test results are only for client's reference.
- 2. Intermediate inspection was carried out immediately without any treatment and the result is only for client's reference.
